September 1997

**Progress Report on the
Investigation of the Slope Failure
at Clark Landfill**

**LTV Steel Company
Indiana Harbor Works
*East Chicago, Indiana***

**Baker Environmental, Inc.
*Coraopolis, Pennsylvania***

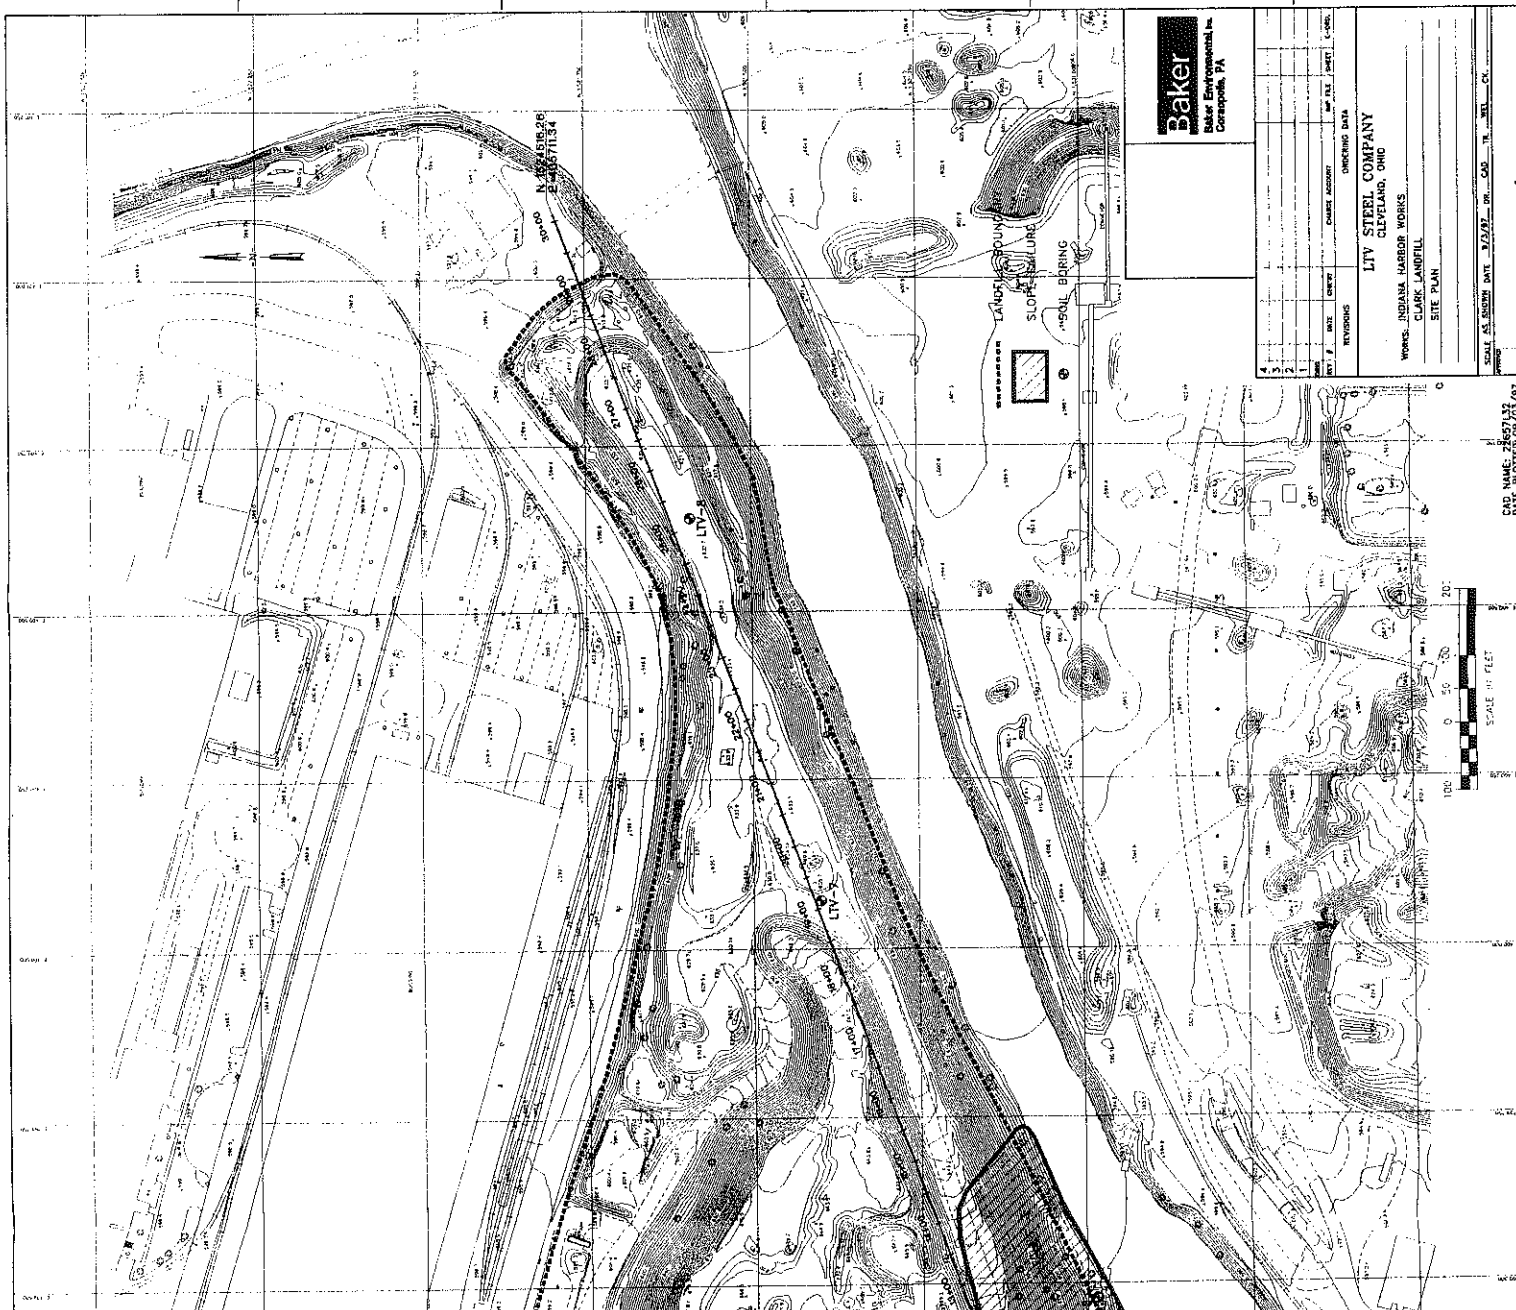
On August 6, 1997 at approximately 8 a.m., the Clark Landfill experienced a slope failure on the southern side of the landfill parallel to the intake flume. Figure 2 shows the area affected by the slope failure. The scarp at the top of the slope was approximately 1,000 feet in length with a maximum vertical shear face of approximately 40 feet. The area of greatest apparent failure was in the southwestern section of the landfill slope. A portion of the slide mass, apparently consisting of slag from berms constructed in the early 1970's as part of the construction of the intake flume, has moved into the flume. As a result, sections of the intake flume are narrower and considerably shallower than that following the completion of the dredging program in 1996.

The landfill support activities are currently concentrated on identifying the cause of the slope failure. The daily survey information collected to date indicate that the slide mass has stabilized in its current configuration. There are cracks on the top of the landfill approximately 100 - 150 feet away from the scarp, but these are believed to a result of tension cracking from the loss of support at the scarp face, and are not believed to be indicative of a potential second major failure at this time.

The locations of the borings are depicted on Figure 2. Initially, soil borings are to be completed in the portion of the landfill that failed (i.e., LTV #1 through LTV #5). Following the installation of these borings, LTV #6 and LTV #7 will be installed. Boring LTV #8 will
